Preventing Water Damage

Trends, risks, and mitigation for water leaks, pipe bursts and plumbing issues

Risk Engineering

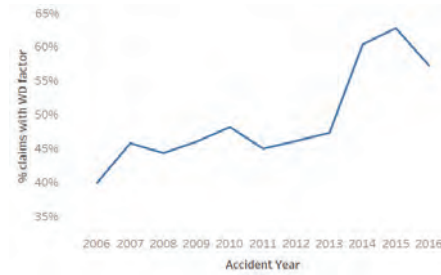
% of Total Claims that Included Water Damage

Chubb has seen a significant increase in the number of claims involving interior water damage since 2013, especially within commercial real estate.

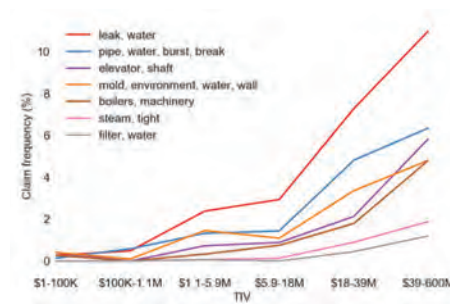
Water Damage Increases in Higher Valued Buildings

Chubb is seeing more water damage claims in taller and higher valued buildings that involve leaks and pipe burst events. (North America)

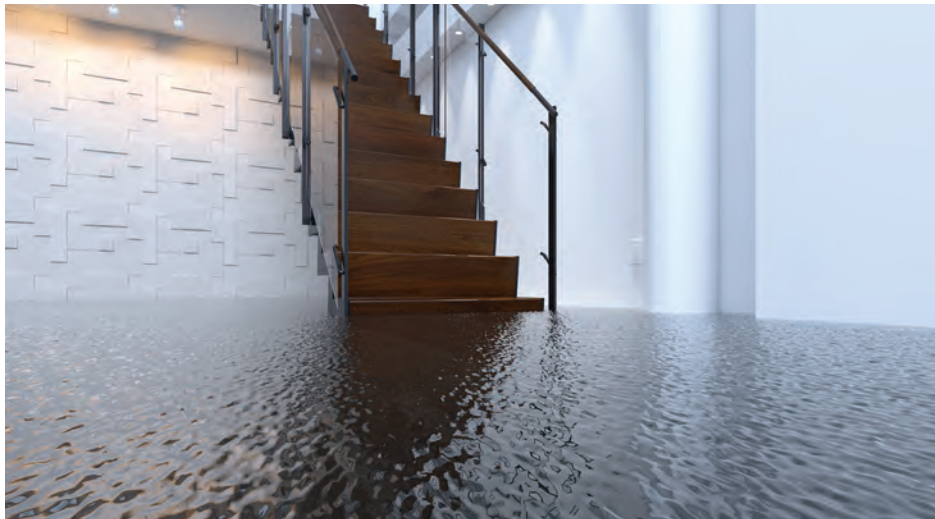
The brass and steel fittings experienced galvanic corrosion resulting in failure of the coupling. Water damage occurred on numerous floors wrecking havoc on suites, mechanical and electrical rooms, offices, and elevators. Main electric bus risers were a total loss, and would take months to replace. Carpeting was totally destroyed on most floors. Business interruption was approximately 6 months. Total loss was \$6.5 million USD.

Galvanic corrosion is one of the most common types of corrosion

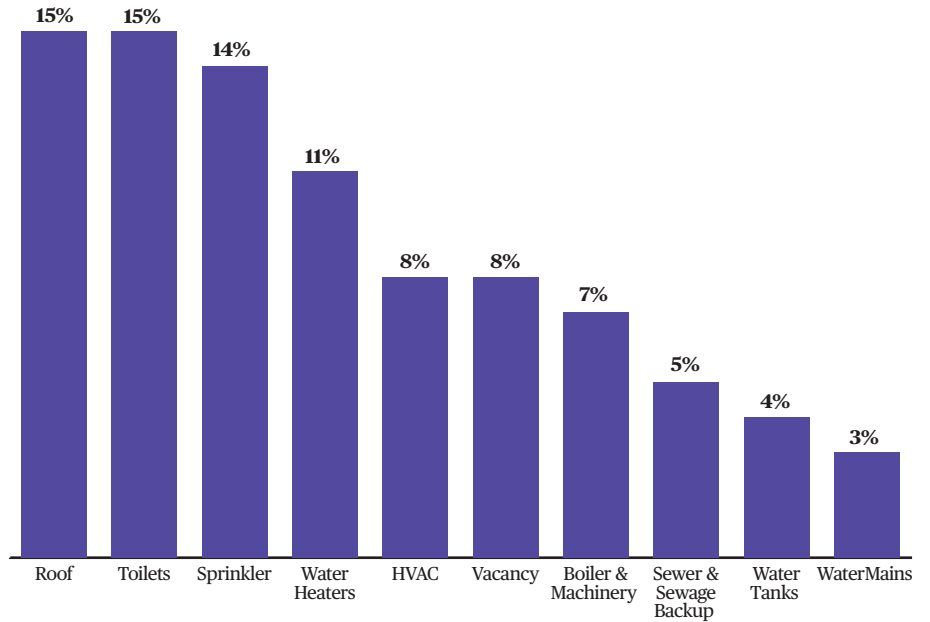
Top 10 Sources of Interior Water Damage Loss in Commercial Buildings

Source: Actual Chubb claim statistics

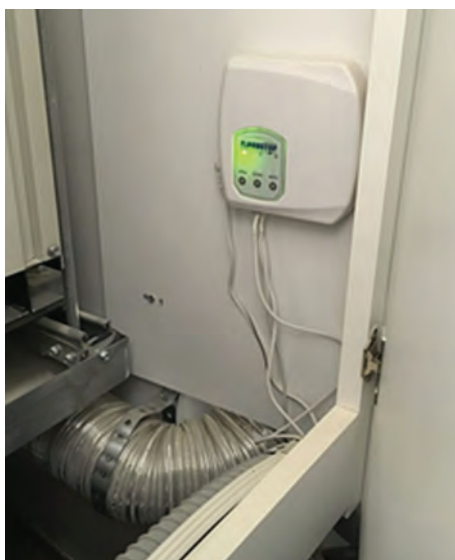
A water leak detection system like this one will alarm if the water level gets too high.

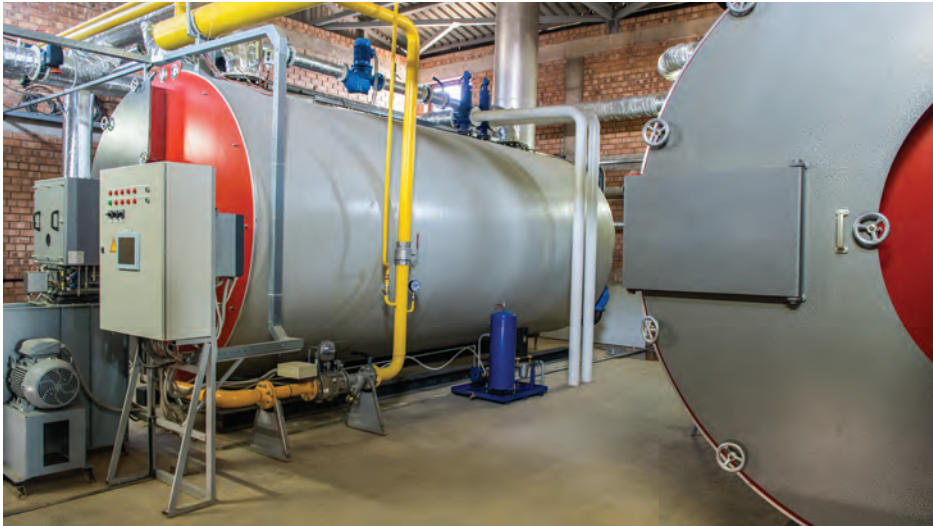
Boiler Rooms are Especially Prone to Water Damage Events
